Robert L. Swaim

Systems Group Chairman

National Transportation Safety Board
Investigations Into Trans World Airlines Flight 800

Describe the research for the ignition
source of a fuel tank in TWA Flight 800 and
our findings

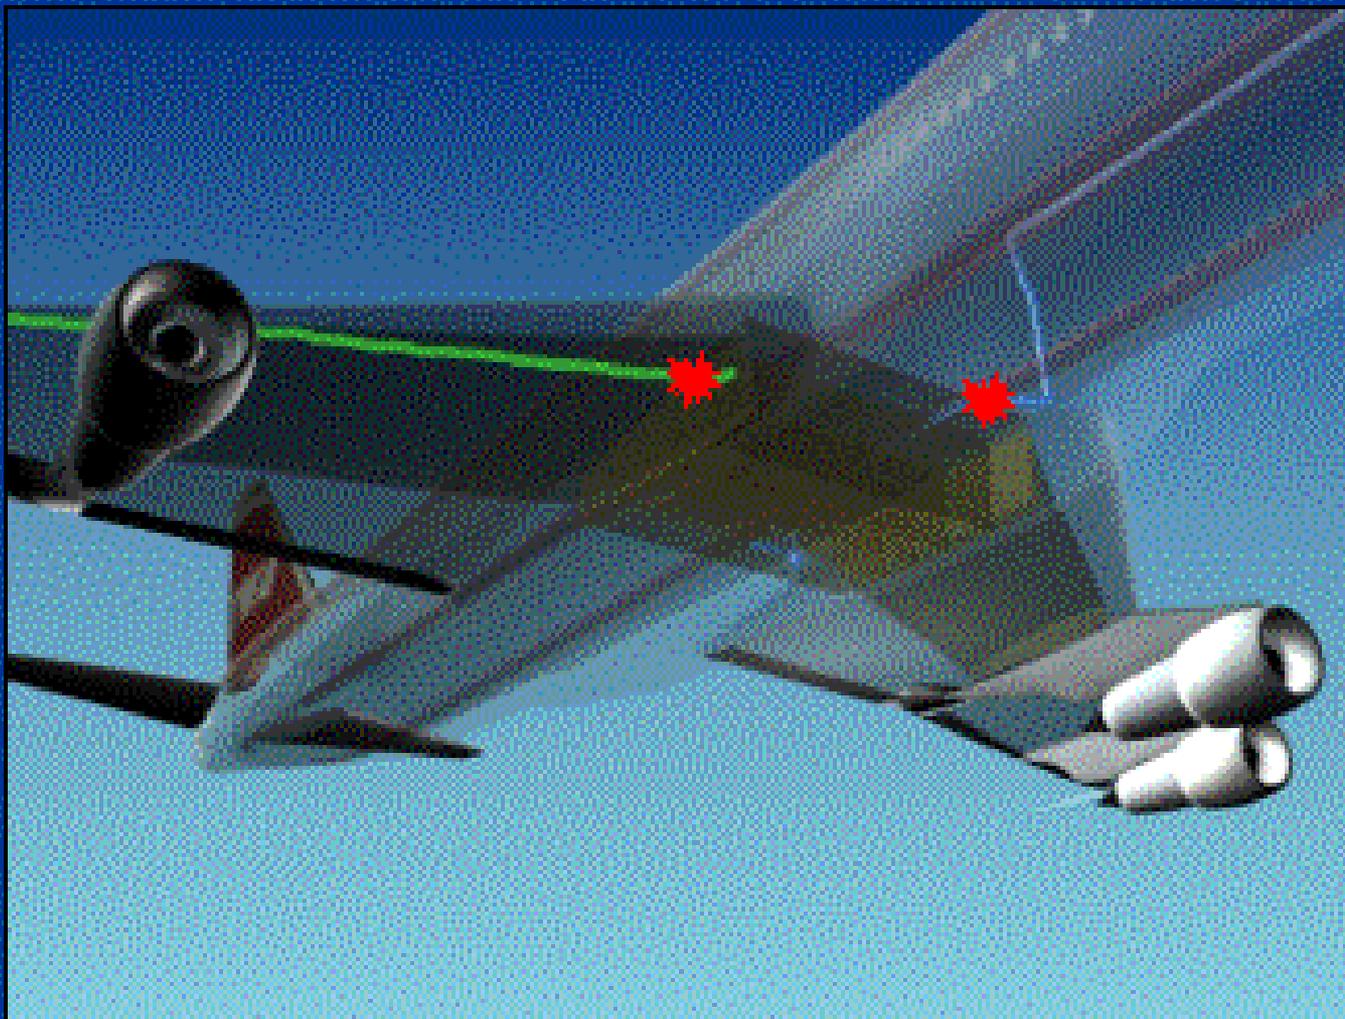
Locations Of Short-Circuit Events

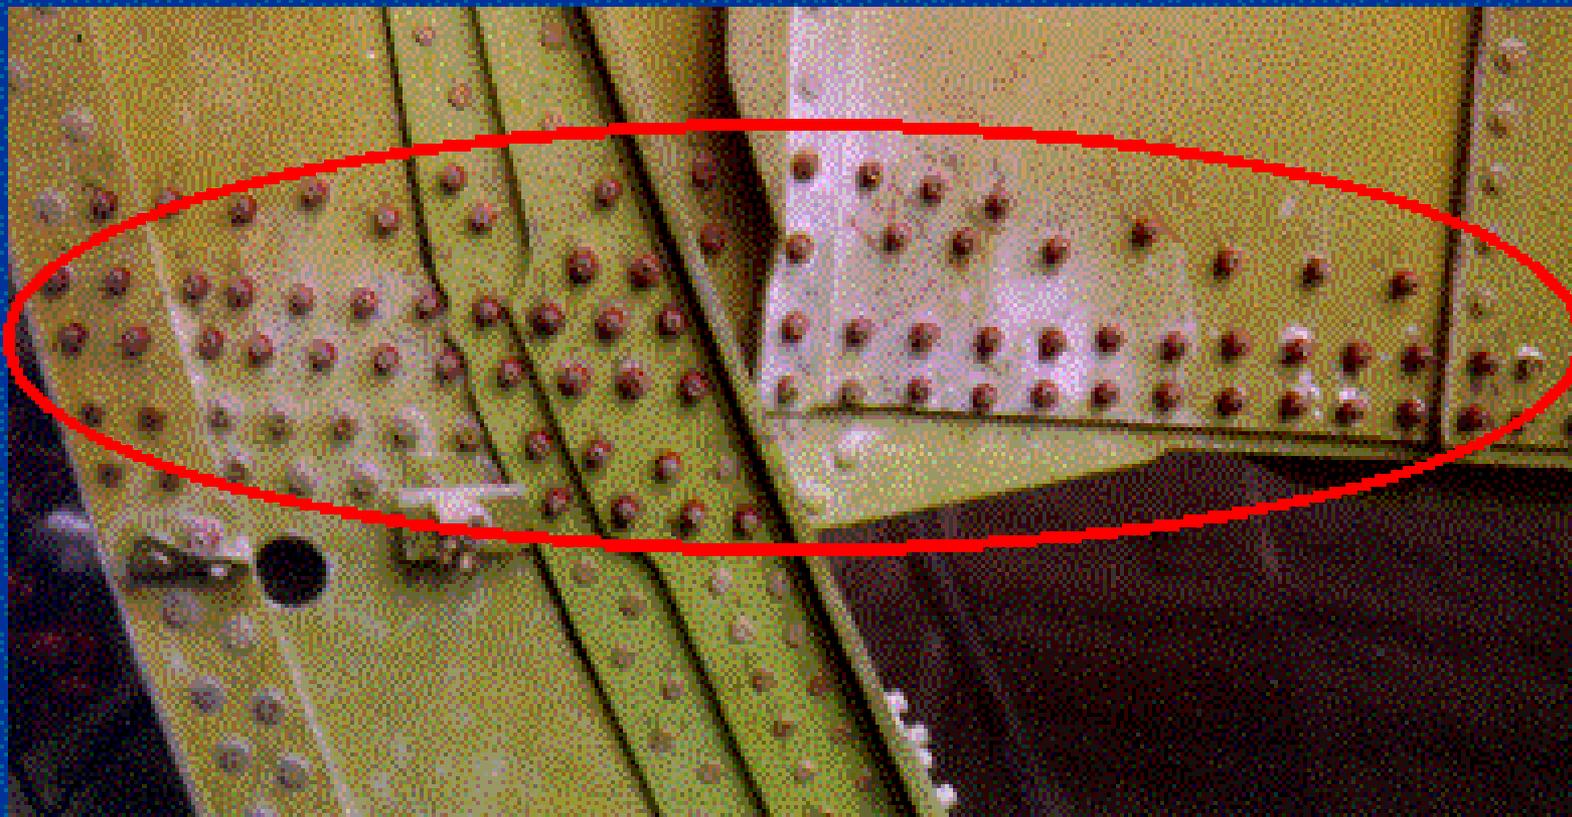
Repairs Were Found Along Routes of FQIS, Fuel Flow, and Lighting Wires

Riveted structure added in TWA 800 avionics compartment

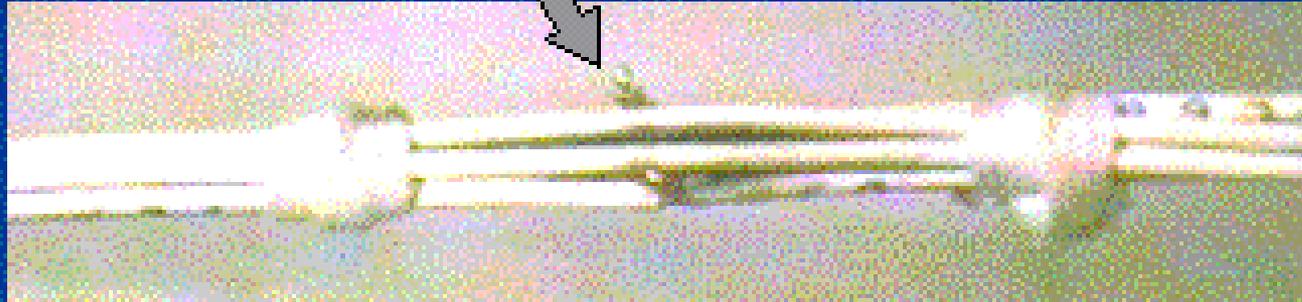
SHAVING IN WIRE BUNDLE

Short Circuit Tests – Drill Shavings

- Shavings Cut through some Wire Insulation
- Other Shavings were Shed by Insulation
- Shavings Could Transfer Energy

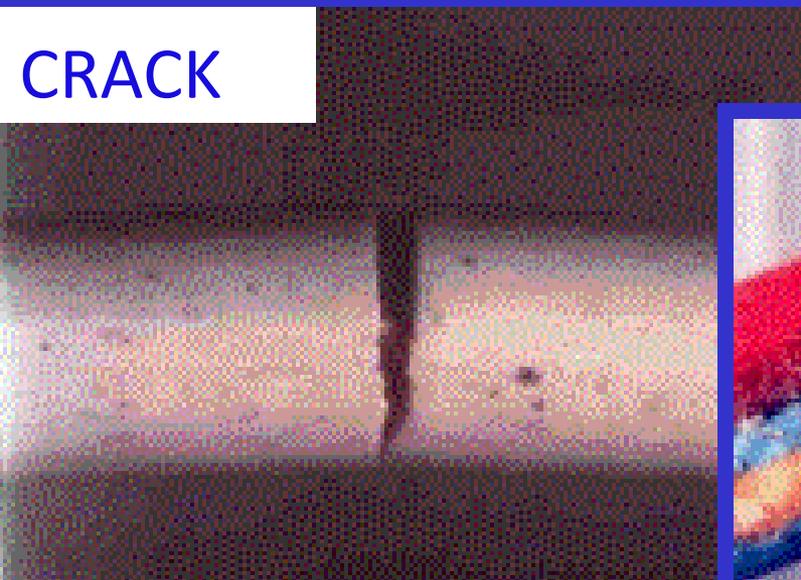
Damaged Wire Found In TWA 800 Wreckage Led To Finding Wire Damage In Other Airplanes

CRACK

Photographs of 747 and DC-10 wires submitted by NTSB to laboratory at Raytheon Corporation

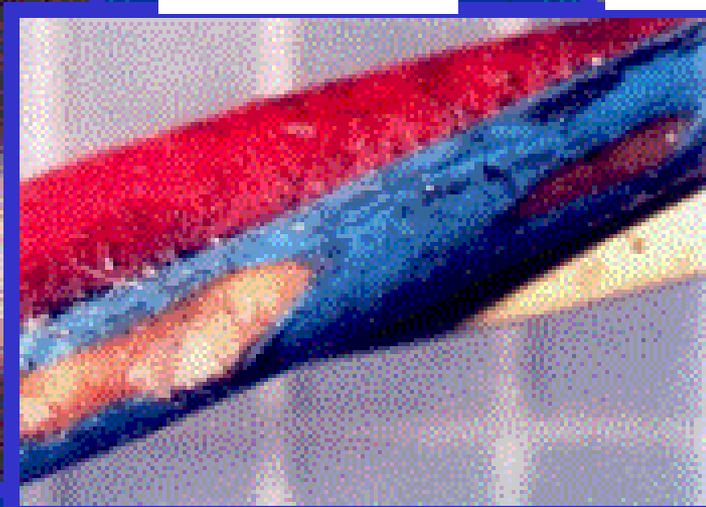
CHAFE

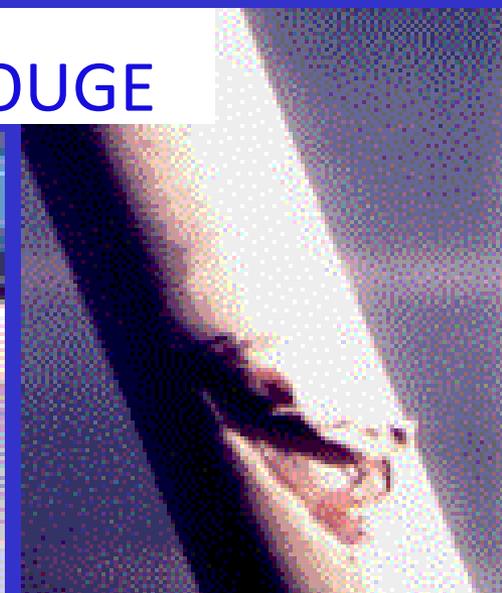
GOUGE

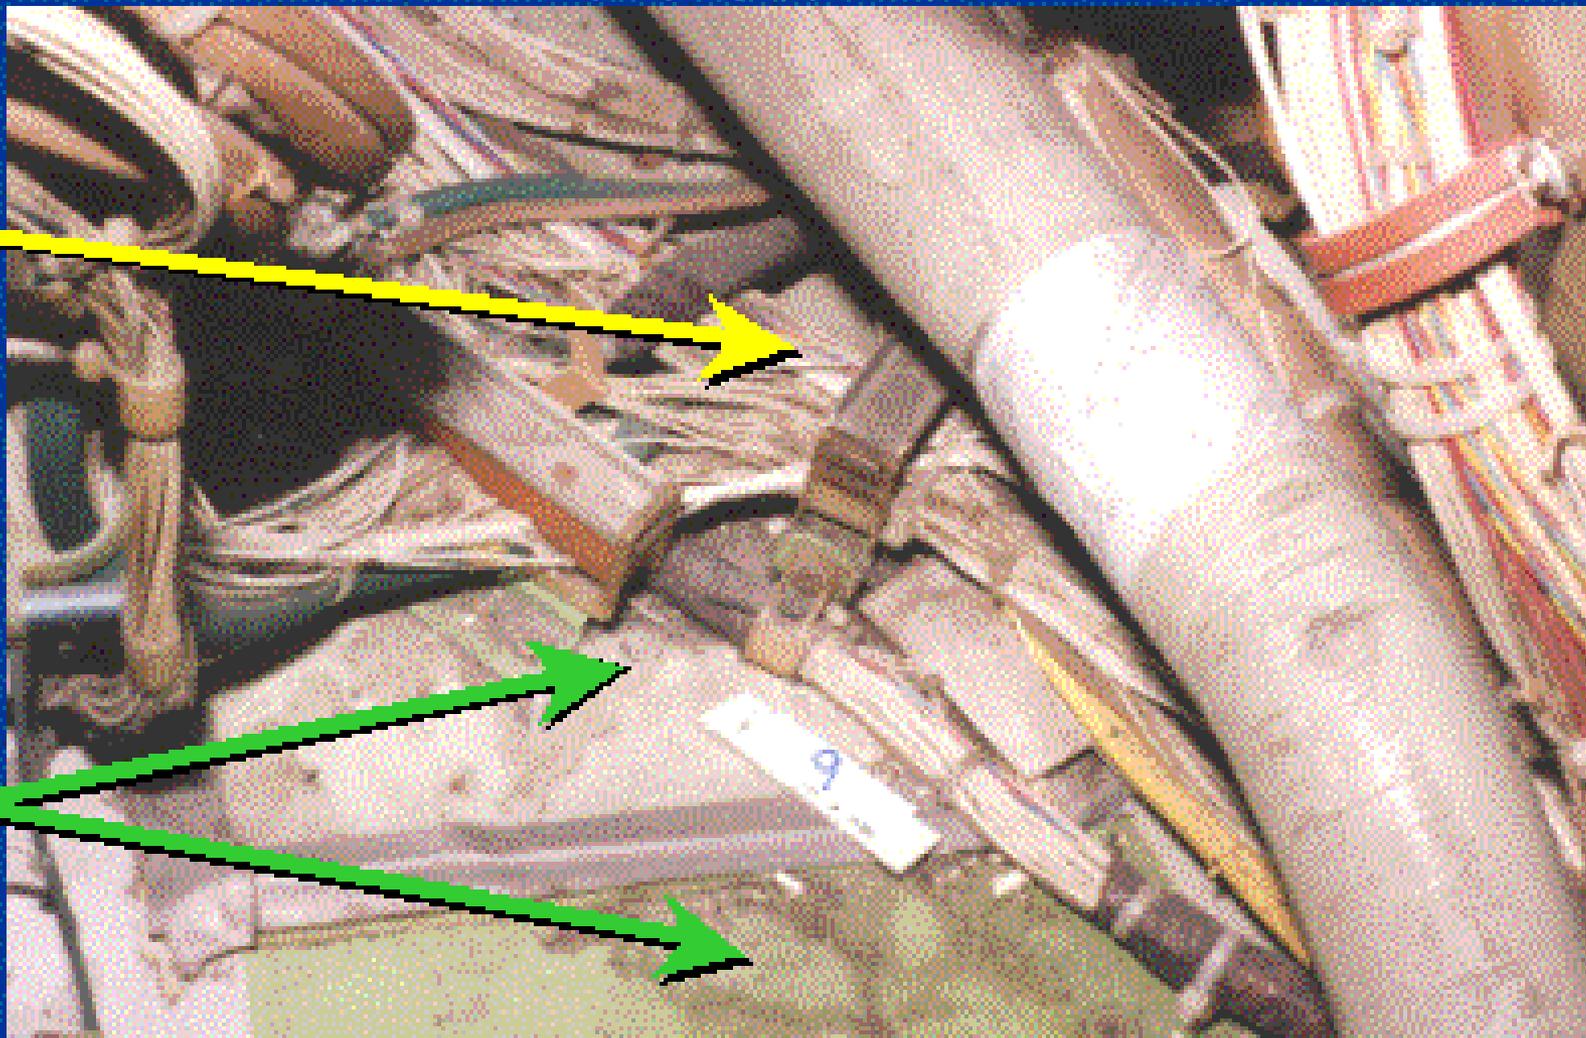
Fuel
Gauge
Wires

Fluid Stains

Fluid
Stains

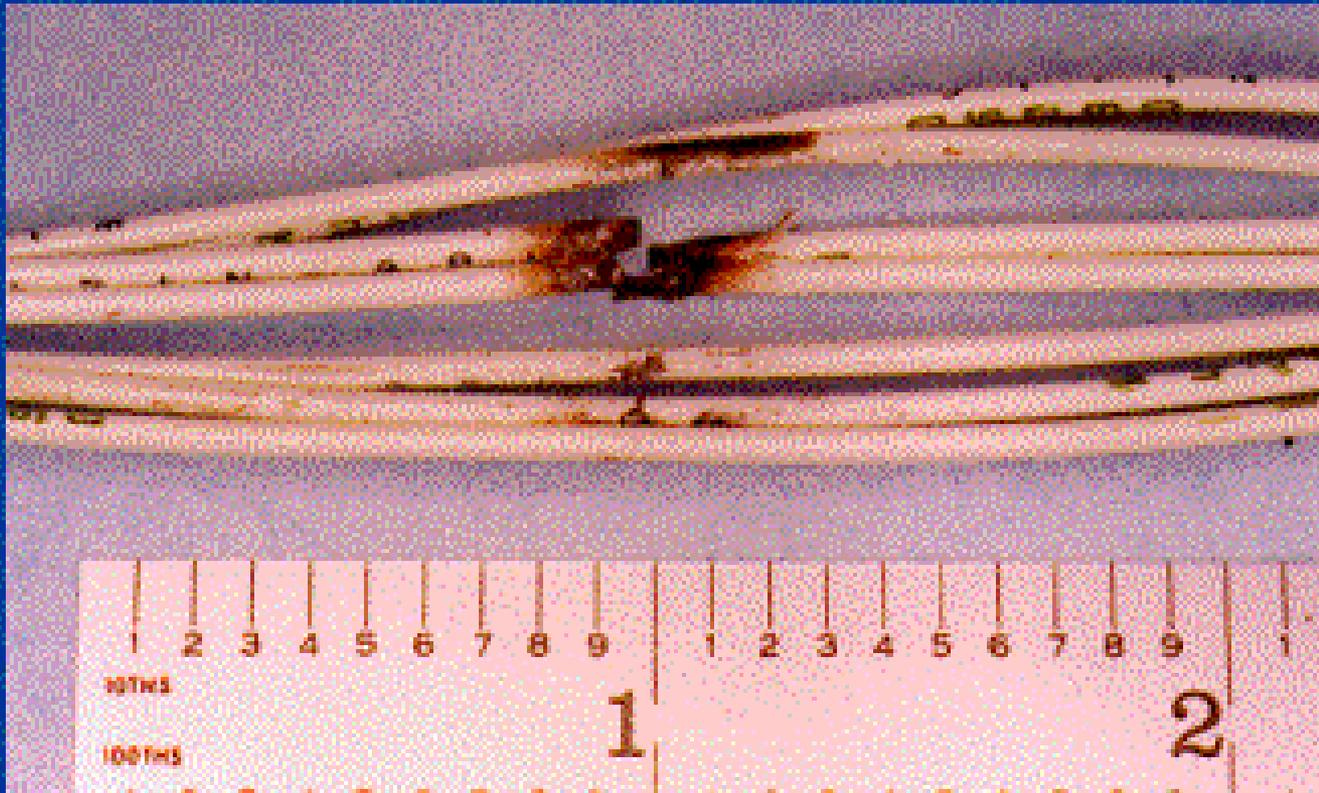
Evidence of a Wet-short

Photo Of Poly-X Wires After % Minutes Of Wet-Short
(Wires From 1970-Era 747)

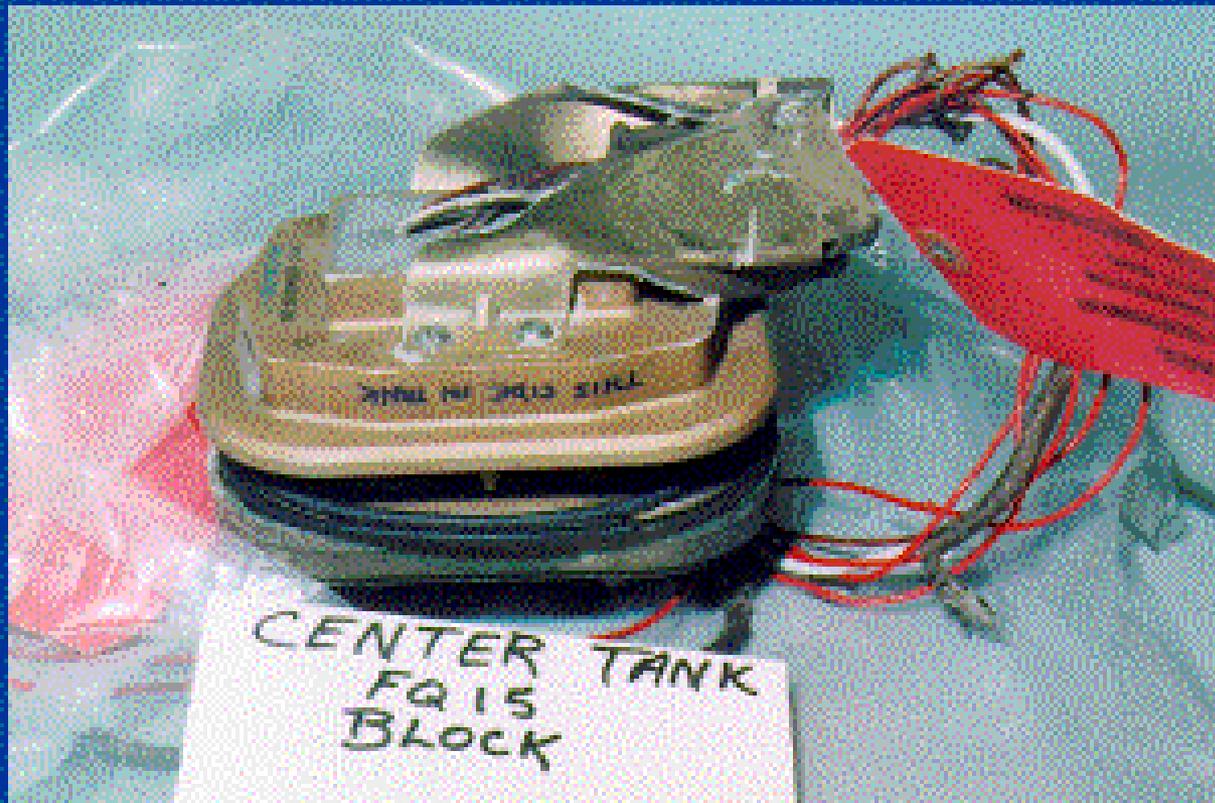
Little Wiring Was Recovered From TWA 800 CWT

Photograph shows TWA 800 CWT spar connector and most of the wiring recovered from CWT

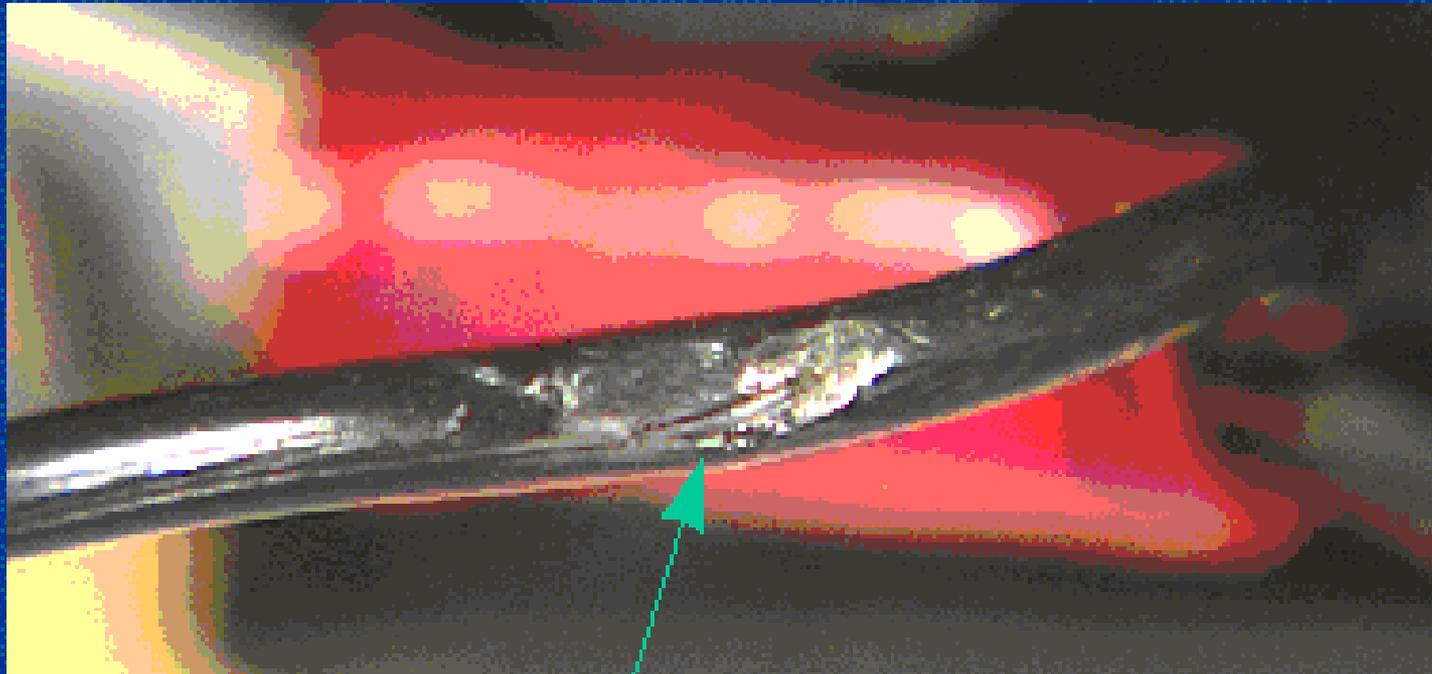
Release Of Energy In CWT By Arcing or Filament Heating

Photograph of exposed copper in 747 fuel tank wire

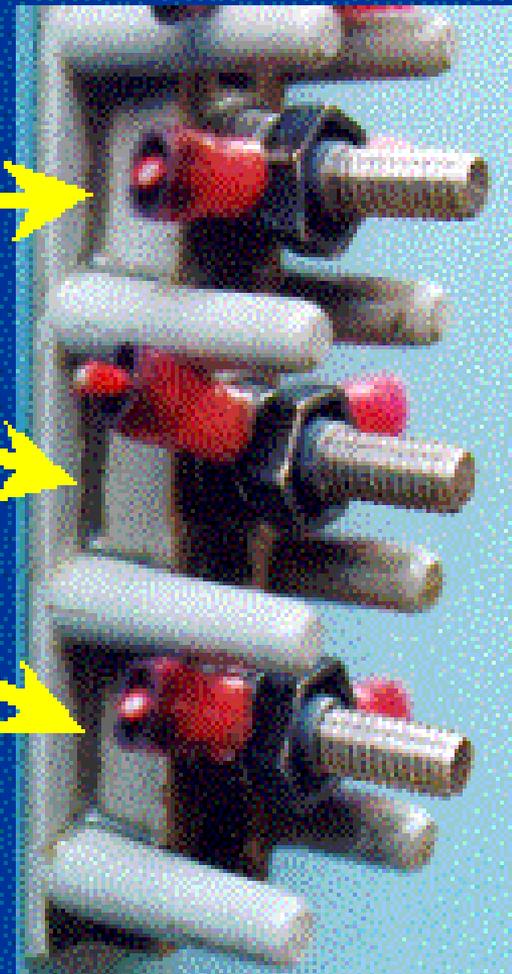
Release Of Energy In CWT Through Sulfide Deposits

Deposits found in
TWA 800 & other
747s, as seen in
corners

Terminal strip from 747 CWT that had malfunctioning fuel gauges.

Sulfidation Remediation Developed

No Silver Exposed to Fuel

Nickel plated wire
Gold plated connector
